# ON SITE DIAGNOSTICS

FOR ARCHITECTURAL CONSERVATION AND RESTORATION

**Bianco, Alessia: On Site Diagnostics for Architectural Conservation and Restoration, Hamburg, Anchor Academic Publishing 2017**

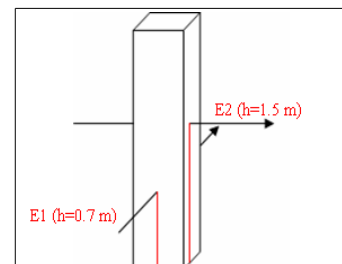
*One of the endoscopies*

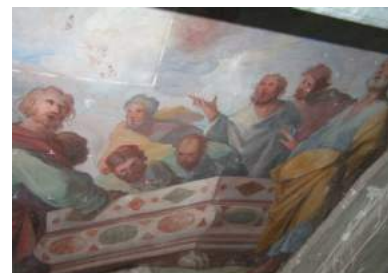
*A thermographic test of a fresco*

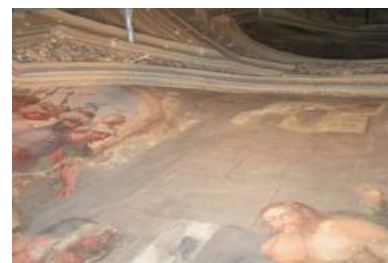
*A thermographic test of a stucco*

Relatively to the stucco decorations, it was observed the presence of extensive alterations of very large portions, evidently due to the excessive weight, producing detachments and downfalls, so, before the retrofitting and preservation project, it was therefore necessary to understand in detail which parts were detached.

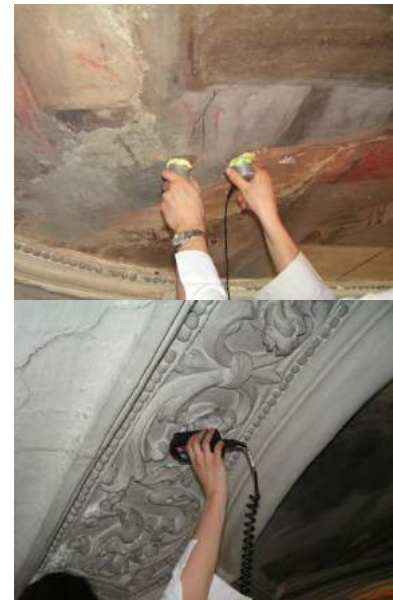
*Ultrasonic and magnetometric tests*

The investigation revealed that even these portions were largely detached, thus highlighting that the nineteenth century retrofitting work did not have a decisive role in the solution of the question about the adhesion between the fresco and the intrados of the vault. This is evidenced by the fact that the resin injections are concentrated in the central portions of nineteenth-century restoration. But even the '60s intervention was proved inadequate, in fact the resins, being inelastic and vitrifying too quickly, did not show a right adhesive capability.

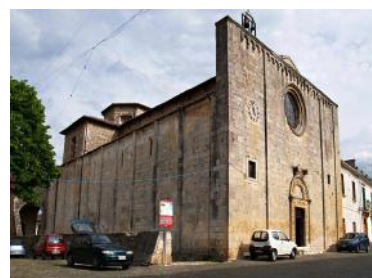
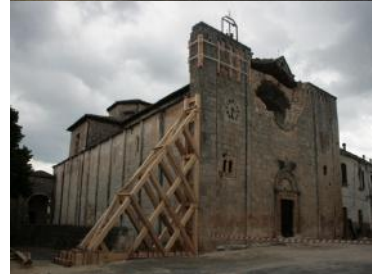
The 2009 earthquake, while not significantly strong in terms of magnitude ( $M=5.9$ ), produced in the small historic St. Eusanio Forconese village, L'Aquila-Italy, and in its main church extended, albeit differentiated, damage, continuing the construction history of this site and its church, several times injured by earthquakes and consequently rebuilt, restored, expanded and transformed.

*St. Eusanio Forconese Church before (top) and after (bottom) the 2009 L'Aquila earthquake*

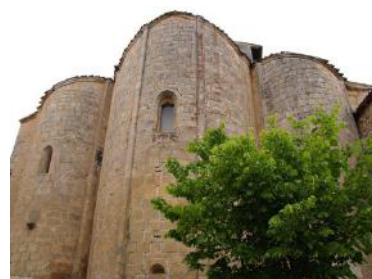
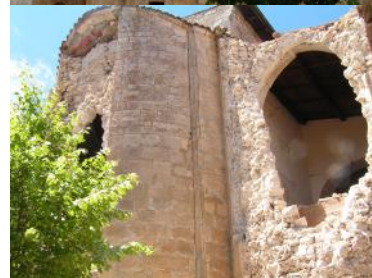
The seismic damage of the church is related to the configuration of the building, which is rather articulated, with the consequence of damaging severely a lot of parts of the church, such as the top of the main façade and the two of the three apses, leading to a significant impairment of its structural behavioural resources. This made necessary to implement a multidisciplinary understanding of the intrinsic and extrinsic structural sources of the church, preparatory to the definition of a retrofitting and restoration project, aimed to reduce its seismic vulnerability; this set of studies included non-destructive diagnostic tests, which pursued the intent to provide useful information about technical characteristics of the different typologies of masonry walls of the church.

*The apses before (top) and after (bottom) the 2009 L'Aquila earthquake*

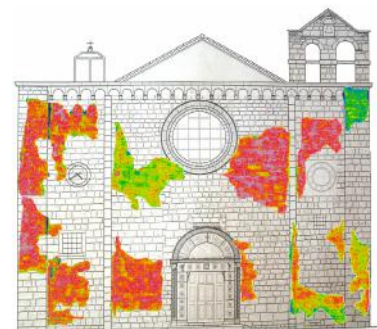
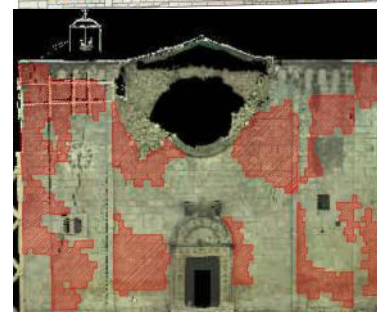
*Thermographic mosaics of the  
detached masonry of the façade*

To overcome this discrepancy some mappings of areas with undifferentiated thermal emission on laser scanner drawing were made, highlighting two types of anomalies, induced by severe material degradation (result of seismic damage), or due to different construction phases.

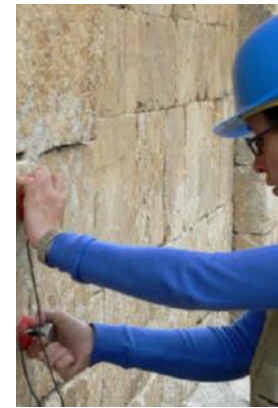
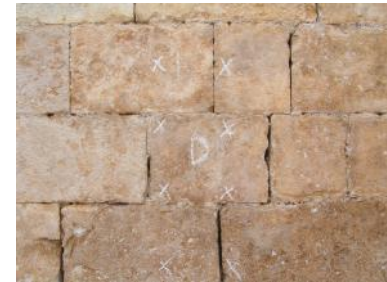
*Results of an ultrasonic test of the main façade*
